# **INDOOR AIR QUALITY REASSESSMENT**

**Burlington High School  
123 Cambridge Street  
Burlington, Massachusetts**

Prepared by:  
Massachusetts Department of Public Health  
Center for Environmental Health  
Emergency Response/Indoor Air Quality Program  
January 2006

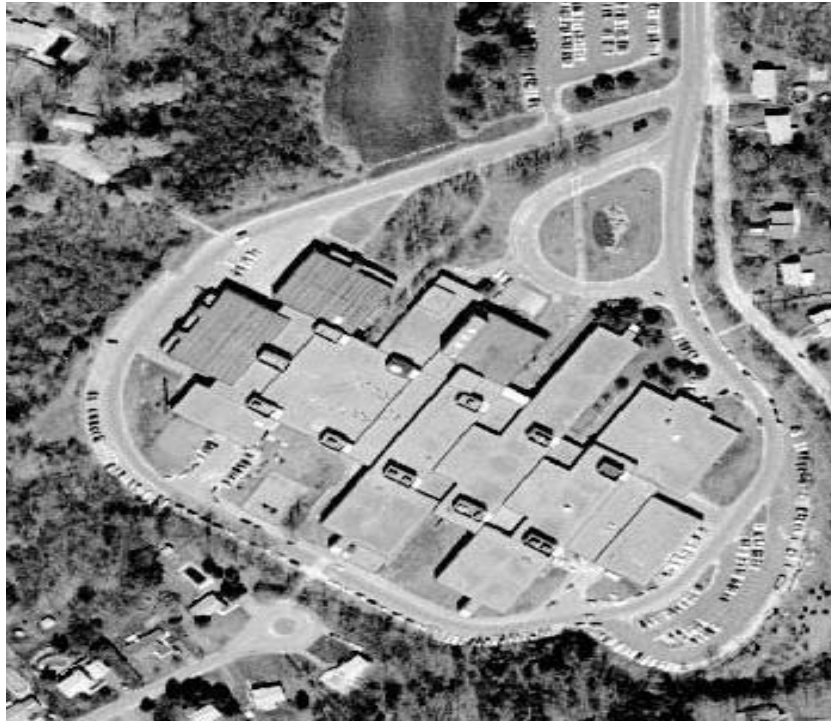
**Picture 1**

The BHS is a cement and brick structure (Picture 1) that was built in the early to mid 1970s. The complex consists of five large wings that are set on sloping land. Each wing is connected by two long, sloping cement corridors (Picture 2). The heating, ventilating and air conditioning (HVAC) system provides both heating and cooling. Windows are openable in selected areas throughout the building.

**BHS is a Multiple Wing, Cement and Brick Structure**

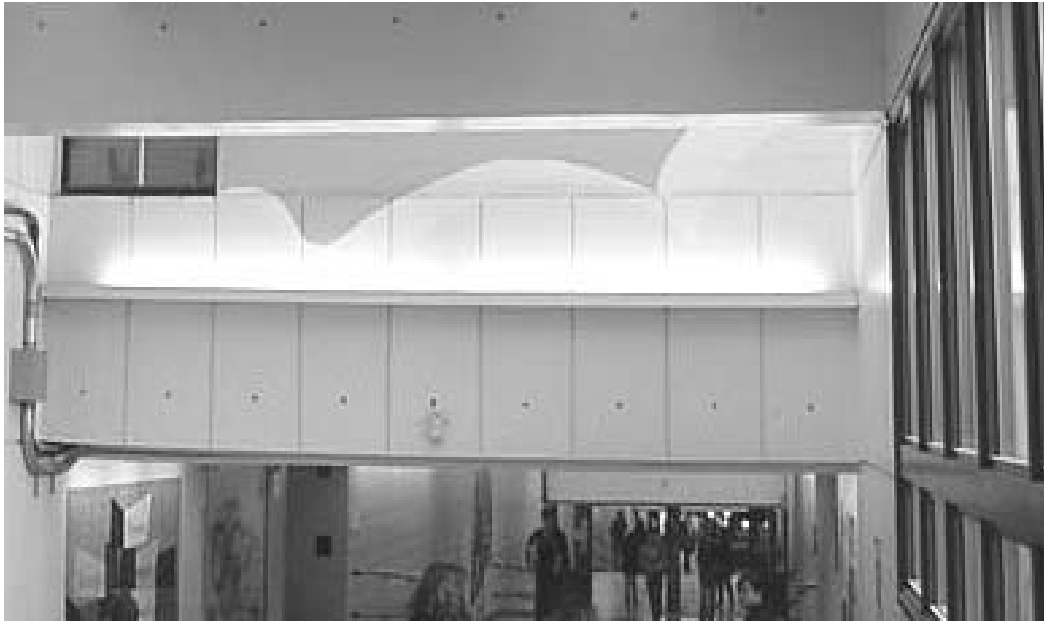
**Picture 2**

**Each Wing is Connected by Two Long, Sloping Cement Corridors**

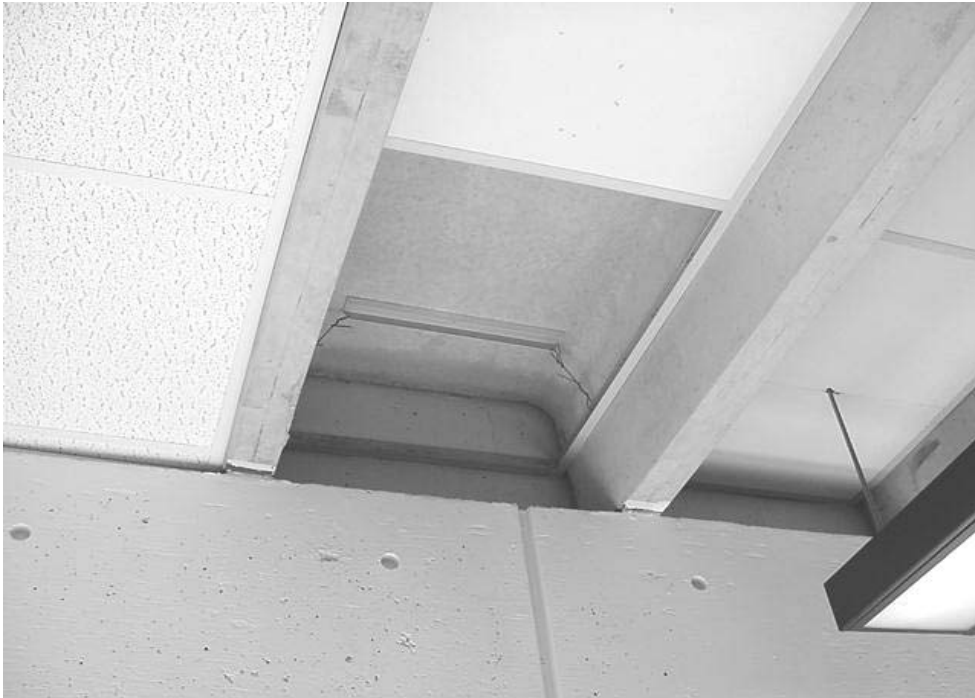
**Picture 3**

The ceiling of each classroom is constructed of pre-stressed concrete slabs that form a corrugated structure that also serves as the roof deck (Picture 3). The underside of this cement deck rests on top of the cinderblock hallway walls of each classroom. The

**Ceiling of Each Classroom**

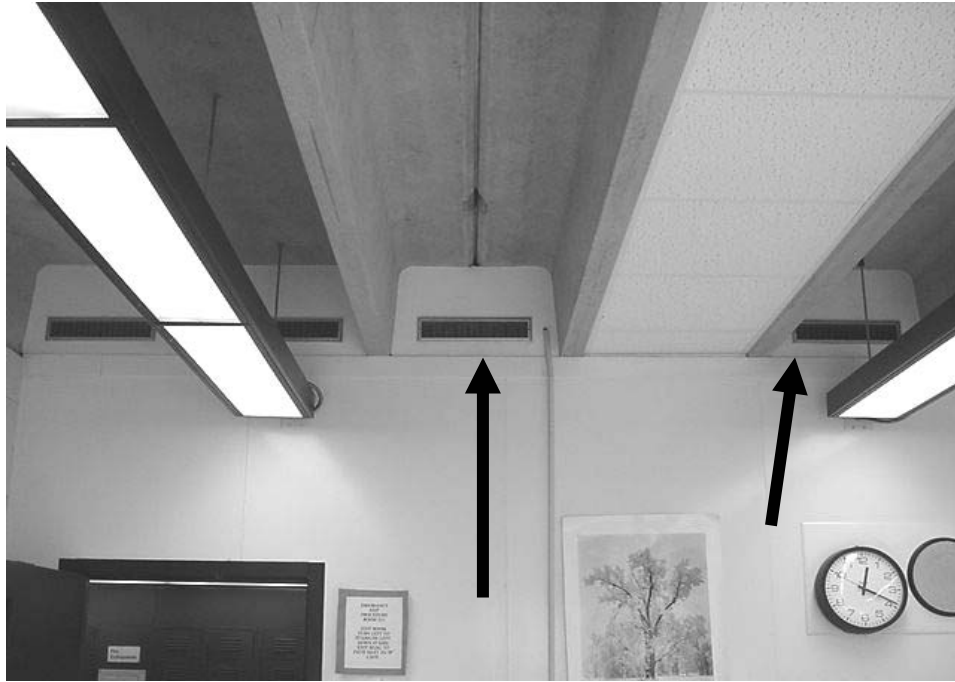
**Picture 4**

space between the classroom hallway walls and the roof deck is sealed with gypsum wallboard (GW) (Picture 4).

**Space between the Classroom Hallway Walls and the Roof Deck Sealed With Gypsum Wallboard**

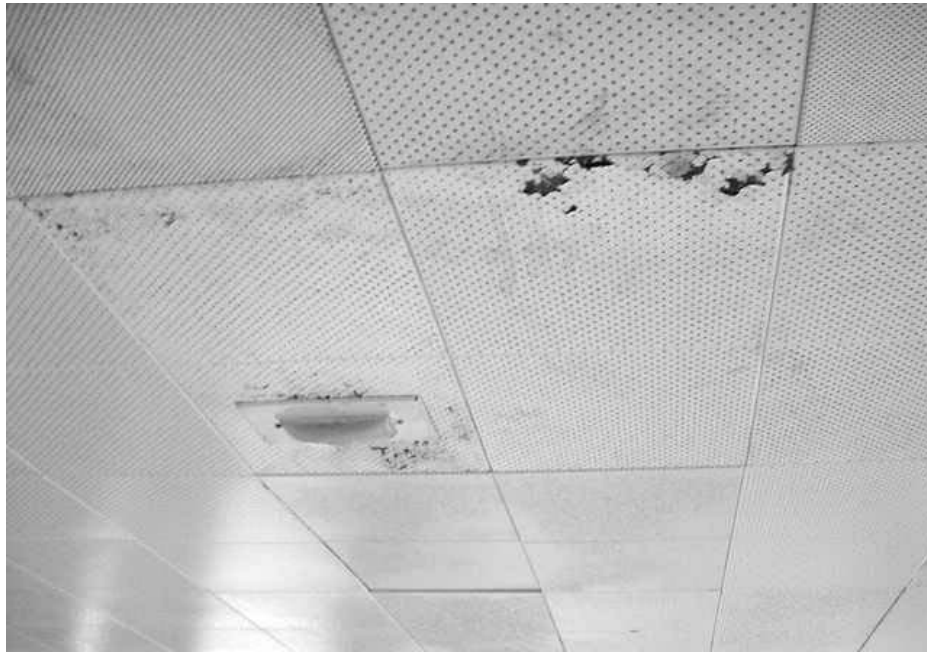
**Picture 5**

The suspended ceiling in the BHS hallways consists of a tamper-resistant metal grate system (Picture 5). In efforts to attenuate hallway noise and reverberation, a suspended ceiling in the BHS hallways is placed on top of each metal grate.

**Tamper-Proof Suspended Ceiling in the BHS Hallways**

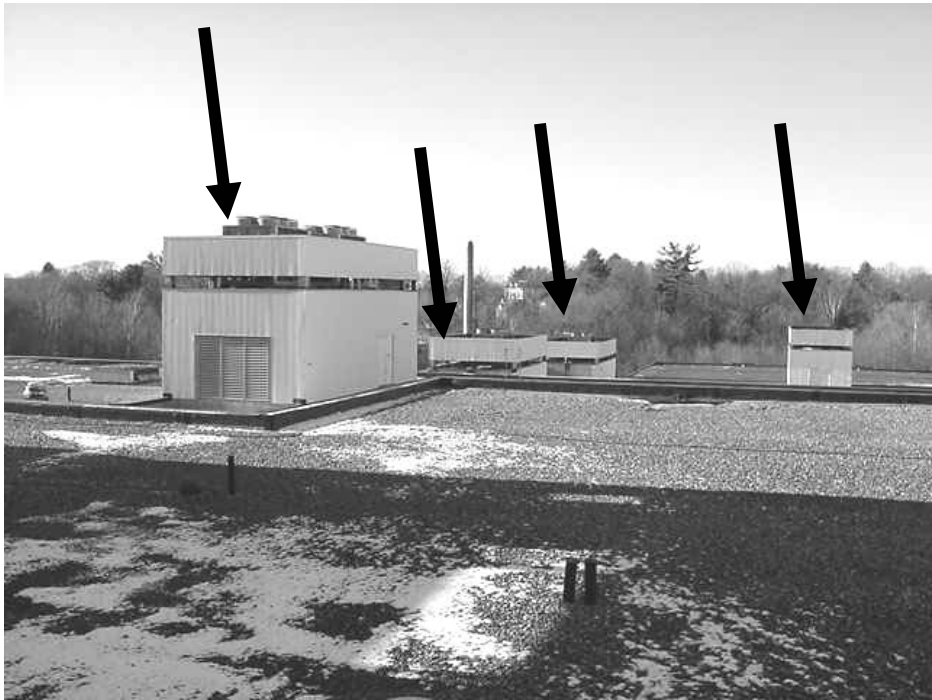
**Picture 6**

Fresh air is provided by air handling units (AHUs) located in rooftop penthouses (Picture 6). The AHUs are connected to ducts that were originally connected to wall-mounted air diffusers. Each of these diffusers were installed in the space between the interior wall and roof decking, in essence directing air down the channel created by the roof deck. Ducted exhaust vents were also installed in this manner, side by side with the fresh air supplies. This configuration likely created the condition of short circuiting, where fresh air delivered to a classroom is readily drawn back into an exhaust vent with minimal mixing in the room. In an effort to improve air mixing in classrooms, the supply vents were extended, which now terminate at a four-way, ceiling-mounted, fresh air supply diffuser (Picture 7).

**Rooftop AHUs**

of Finance and Operations, Burlington Public Schools, the HVAC system was last balanced when the fresh air diffusers were extended several years ago. It is recommended that existing ventilation systems be re-balanced every five years to ensure adequate air systems function (SMACNA, 1994).

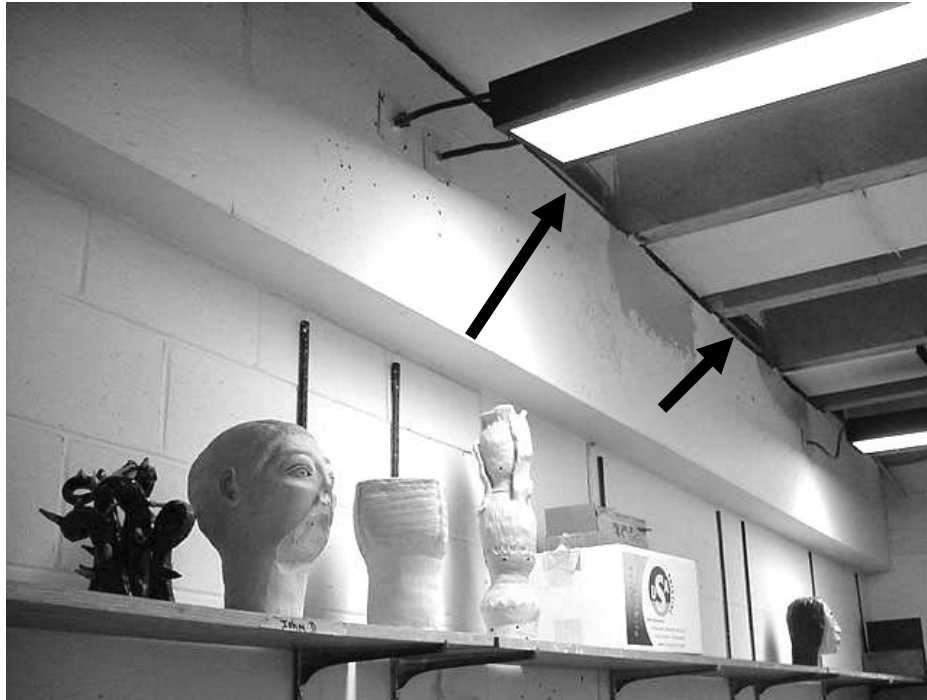
**Picture 16**

**General HVAC System Supply and Exhaust Vents in the Kiln Room**
